TO: ALL REGENCY COMMUNICATIONS PROFESSIONAL SALES & SERVICE CENTERS
ALL REGENCY COMMUNICATIONS PROFESSIONAL SALES REPRESENTATIVES

MODELS AFFECTED: XLU152, XLU1515

ITEM: DESIGN CHANGES TO IMPROVE RADIO PERFORMANCE
IN HIGH SYSTEMS NOISE ENVIRONMENTS

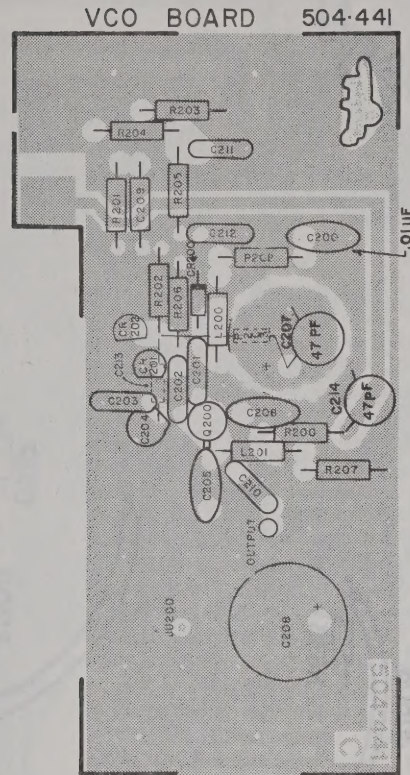
DIAGRAM # 1 VCO BOARD

- b. The following caps have been added to the VCO Board (see Diagram #1)

C207 = 47pF (1524-0470-002)

C214 = 47pF (1524-0470-002)

and C200 changed from 150pF to .01μF (1502-0103-004)

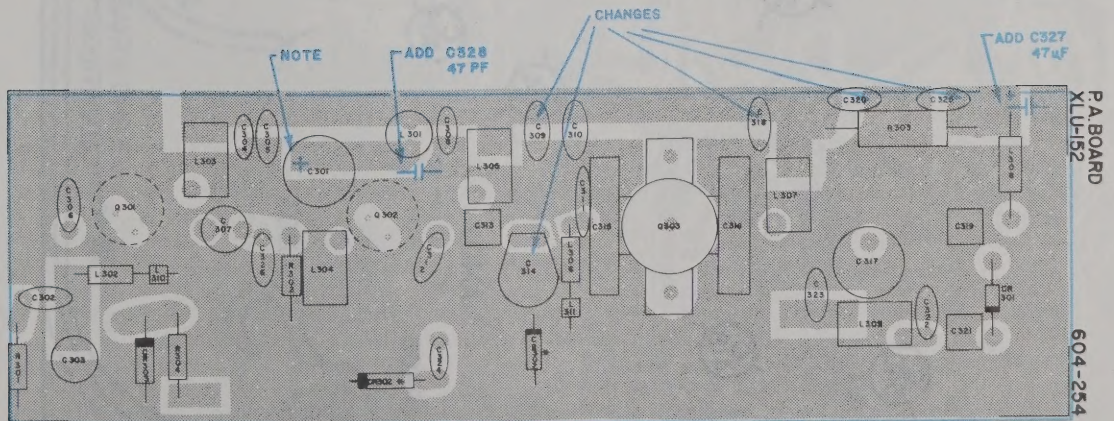
DIAGRAM # 3 - PA BOARD

(3) PA Board Modifications (See Diagram #3)

Changed C318 to 1507-0101-002

Changed C325, C320 and C309 to 47pF (1524-0470-002)

Changed C314 to 2-10pF (1517-0000-043)

Added C328 = 47pF (1524-0470-002)

Added C327 = 47μF 16V (1513-0470-002)

It has been ensured that components on PA Board do not have long lead lengths.

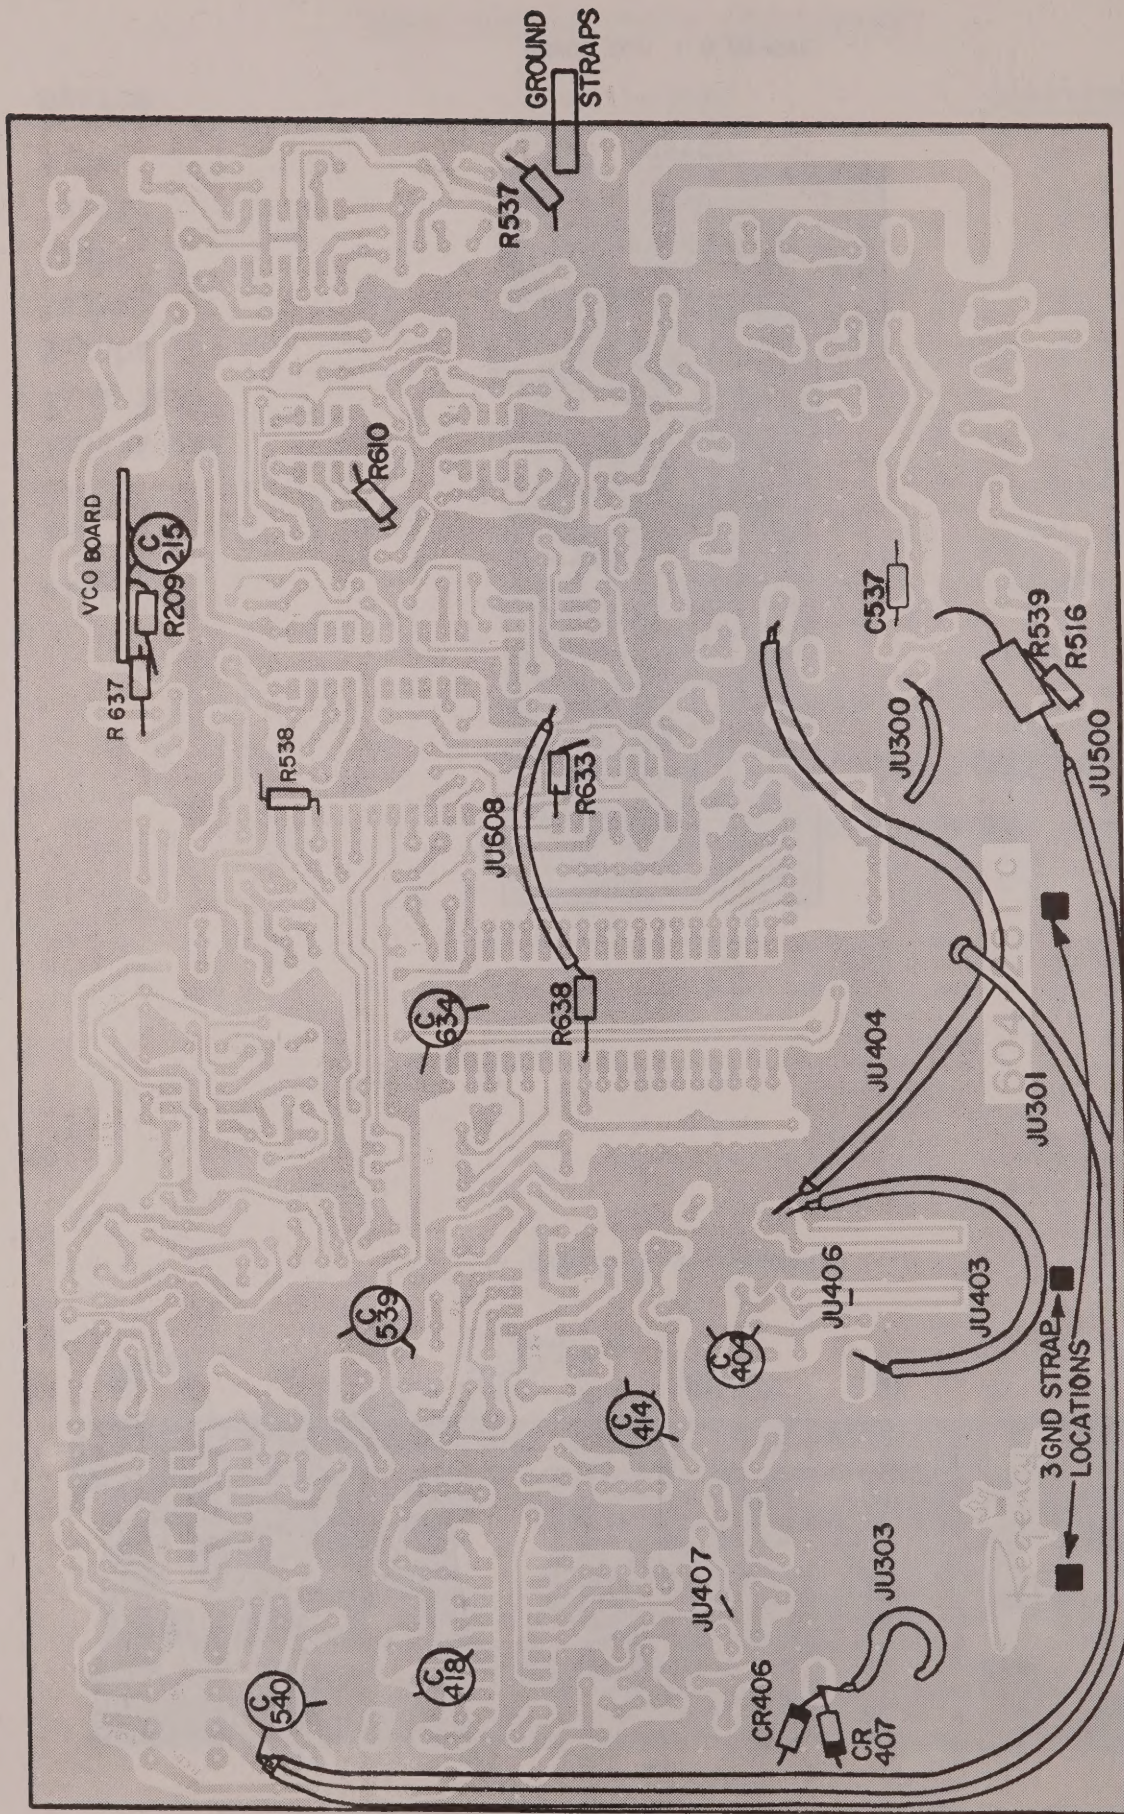
DIAGRAM# 2

(4) Main Board Modifications (See Diagrams #2 and #6)

Moved C537 to underside of board

Removed R516 = 330Ω

Changed C534 to 150pF (1538-0151-601)

Changed C535 to 47pF (1524-0470-002)

Added R209 = 100Ω (4704-0101-032) in series with 8V supply to VCO Board

Added C215 = 47pF (1524-0470-002)

Added R516 = 220Ω (4704-0221-032) at L501 input to ground on underside

Changed C543 to 1000μF 16V (1513-3254-717) and changed position to across C537
